Subject: Addendum to Remedial Action Plan – AOC 1, AOC 5, AOC 9 and AOC 14
Closure Plan Part 1 CSA
Montville Generating Station
Montville, Connecticut

Attachment 1

CSA Photos

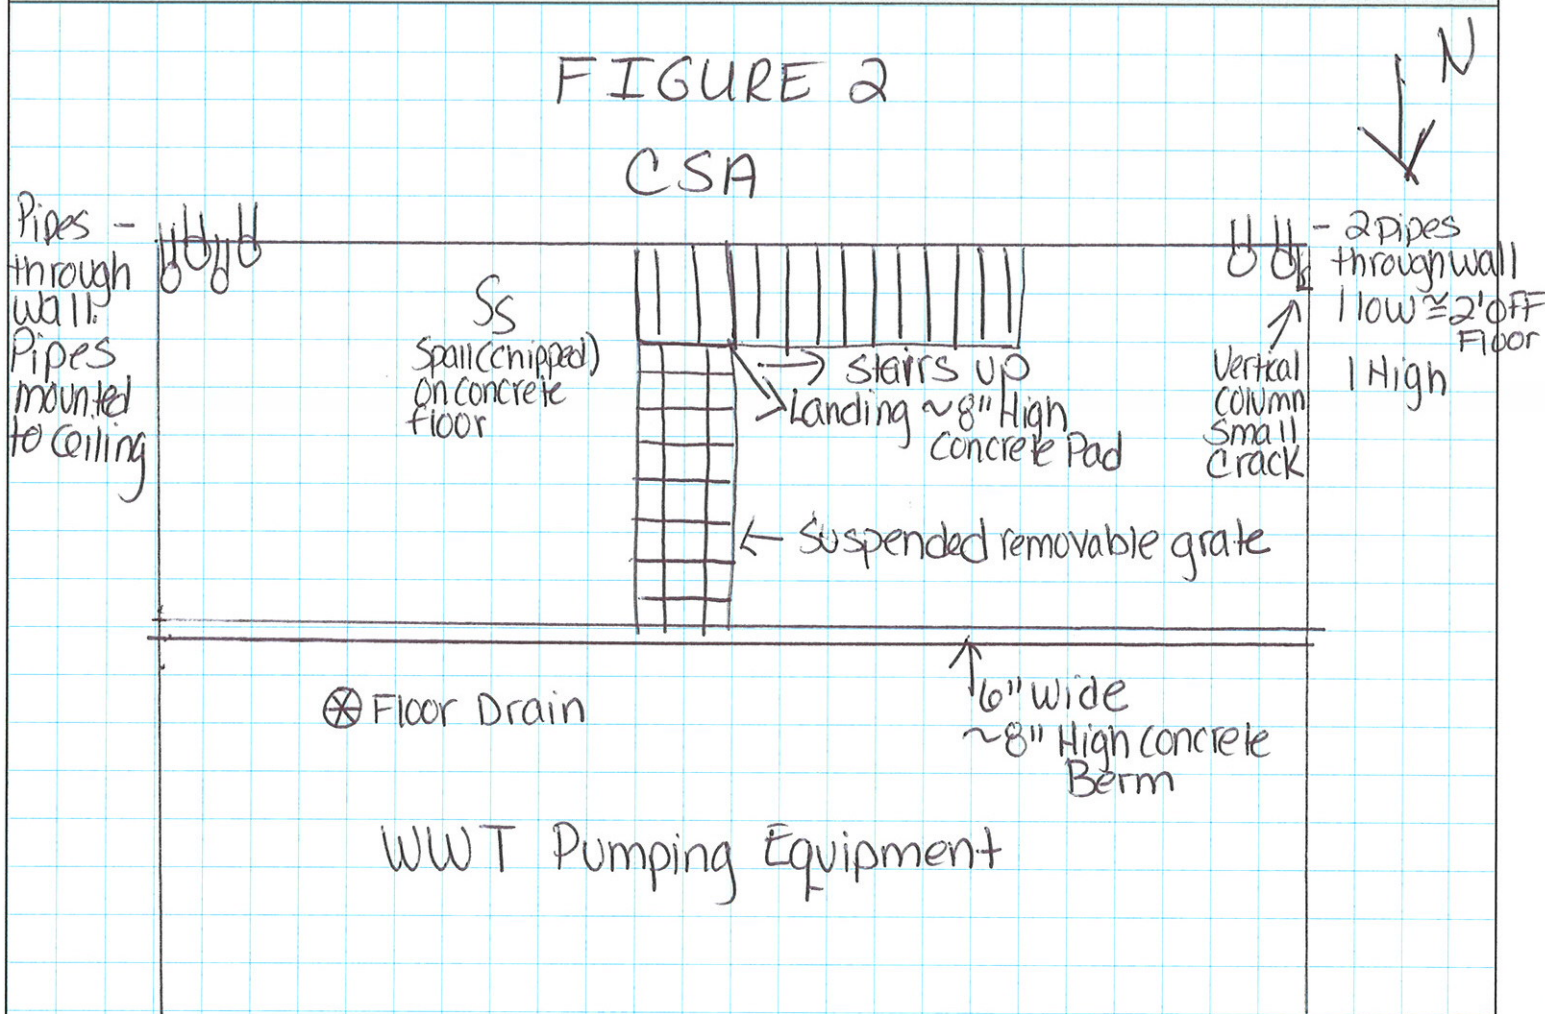
Field Activity Subject: CSA Inspection

- There were no obvious stains on the CSA floor with the exception of mineral staining from water in the southwest and west areas of the CSA.
- The integrity of the concrete floor appears to be in good condition with the exception of a small section of chipped concrete floor in the southeast area of the CSA.
- The integrity of the concrete walls and berm appears to be in relatively good condition with the exception of a small surficial crack in the vertical column located in the southwest corner of the CSA.
- A capped pipe was observed in the east side of the CSA. This pipe vertically penetrates the CSA floor and the pipe destination and use is unknown.
